**BOLSA CHICA LOWLANDS RESTORATION PROJECT
2008 MAINTENANCE DREDGING
SEDIMENT CHARACTERIZATION AND
COMPATIBILITY TESTING RESULTS**

Merkel & Associates, Inc.
5434 Ruffin Road
San Diego, CA 92123
Phone: (858) 560-5465
Fax: (858) 560-7779

June 2008

DRAFT SAMPLING AND ANALYSIS PLAN BOLSA CHICA LOWLANDS RESTORATION PROJECT SEDIMENT CHARACTERIZATION STUDY

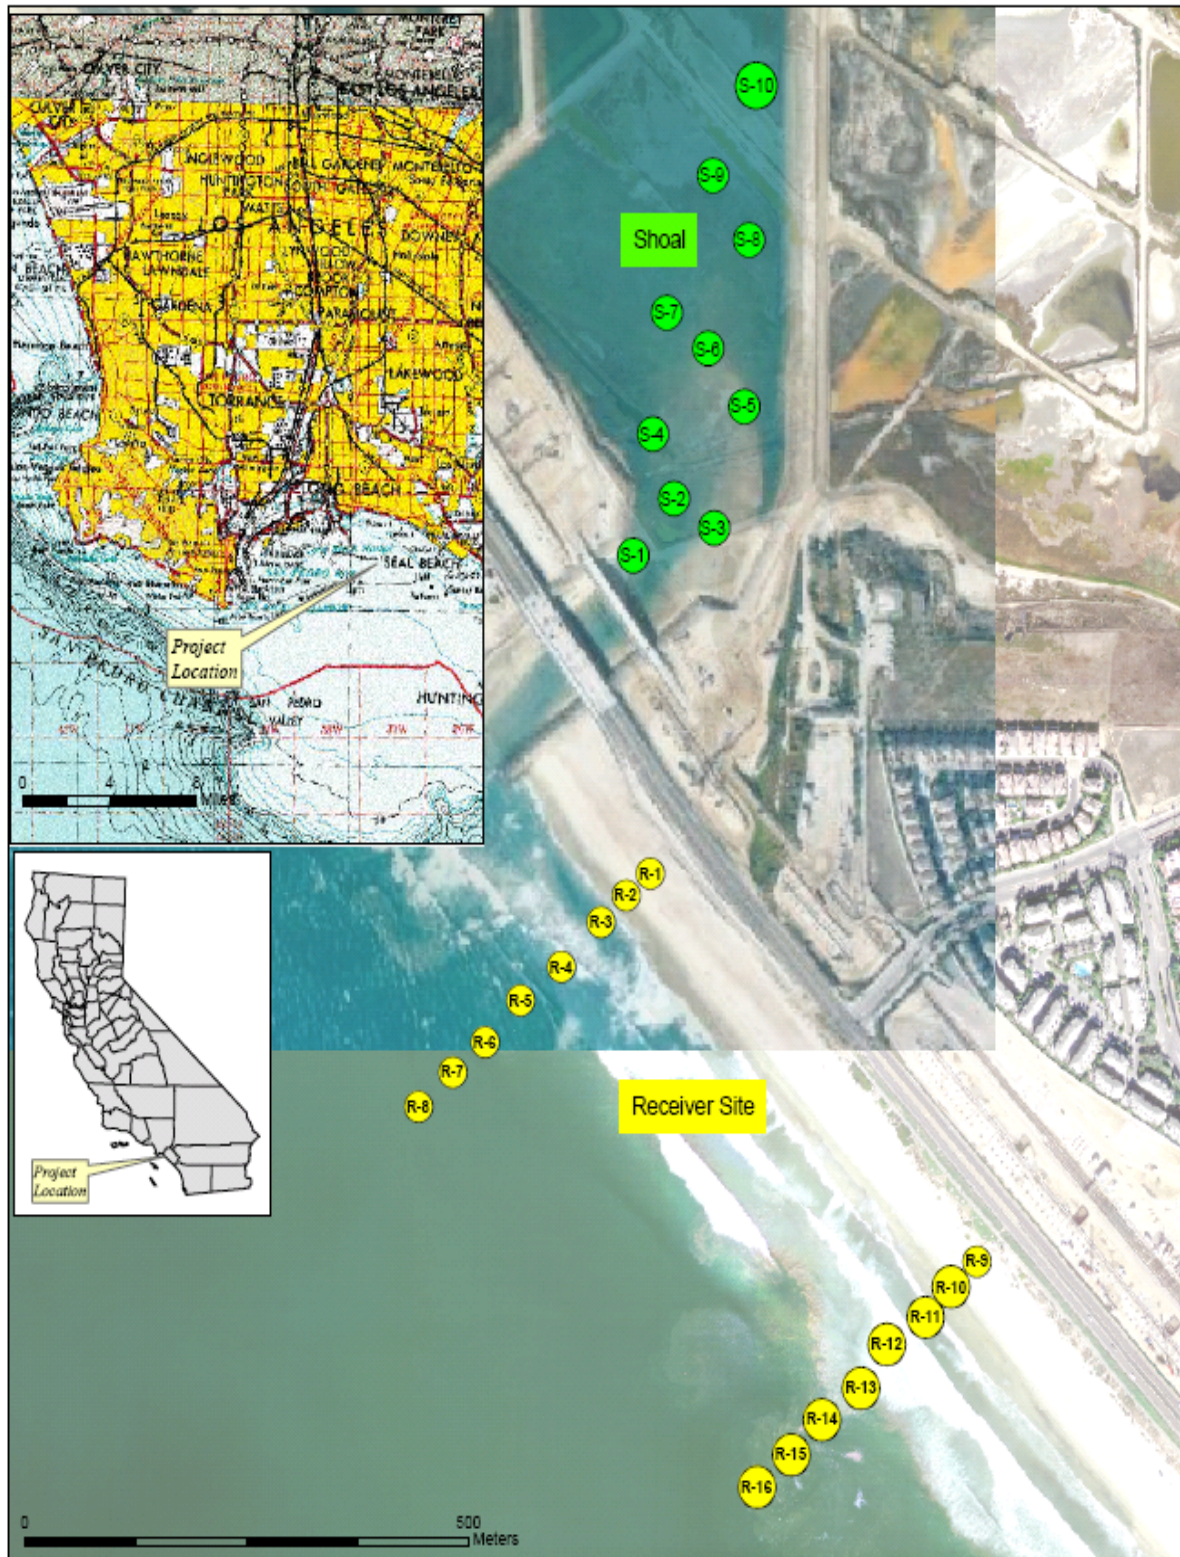
Figure 2. Sample Locations at Tidal Basin and Receiver Site

Ten sample locations were sampled in accordance with the SAP. Locations were selected to best characterize the sediment within the FTB (Figure 2). Samples were to be collected to the as-built design depth at each location, with target and actual penetration for each location provided in the Table 1.

Site	Sample Location	Longitude	Latitude	Existing Elevation (NAVD ft)	Design Elevation (NAVD ft)	Target Penetration (ft)	Actual Penetration (ft)
Shoal (Basin)	S-1	118° 2.091	33° 41.046	2.9	-4.3	7.1	7.0
	S-2	118° 2.062	33° 41.077	3.3	-4.3	7.0	7.0
	S-3	118° 2.033	33° 41.062	-0.9	-4.6	3.7	4.0
	S-4	118° 2.079	33° 41.111	0	-4.3	4.3	4.5
	S-5	118° 2.013	33° 41.127	1.6	-4.9	6.5	6.0
	S-6	118° 2.039	33° 41.157	1.6	-4.6	6.2	6.0
	S-7	118° 2.070	33° 41.176	0.3	-4.6	4.9	5.0
	S-8	118° 2.011	33° 41.215	0.6	-4.6	5.0	5.0
	S-9	118° 2.038	33° 41.250	0.9	-4.3	5.2	5.0
	S-10	118° 2.007	33° 41.298	0.9	-4.6	5.5	5.5
Receiver Site (Beach)	R-1	118° 2.076	33° 40.878	+12	NA	0.5	0.5
	R-2	118° 2.093	33° 40.866	+6	NA	0.5	0.5
	R-3	118° 2.111	33° 40.851	0	NA	0.5	0.5
	R-4	118° 2.139	33° 40.827	-6	NA	0.5	0.5
	R-5	118° 2.169	33° 40.808	-12	NA	0.5	0.5
	R-6	118° 2.194	33° 40.786	-18	NA	0.5	0.5
	R-7	118° 2.217	33° 40.770	-24	NA	0.5	0.5
	R-8	118° 2.242	33° 40.751	-30	NA	0.5	0.5

R-9	118° 1.833	33° 40.674	+12	NA	0.5	0.5
	R-10	118° 1.852	33° 40.660	+6	NA	0.5	0.5
	R-11	118° 1.873	33° 40.644	0	NA	0.5	0.5
	R-12	118° 1.898	33° 40.624	-6	NA	0.5	0.5
	R-13	118° 1.924	33° 40.606	-12	NA	0.5	0.5
	R-14	118° 1.945	33° 40.588	-18	NA	0.5	0.5
	R-15	118° 1.967	33° 40.569	-24	NA	0.5	0.5
	R-16	118° 1.991	33° 40.552	-30	NA	0.5	0.5

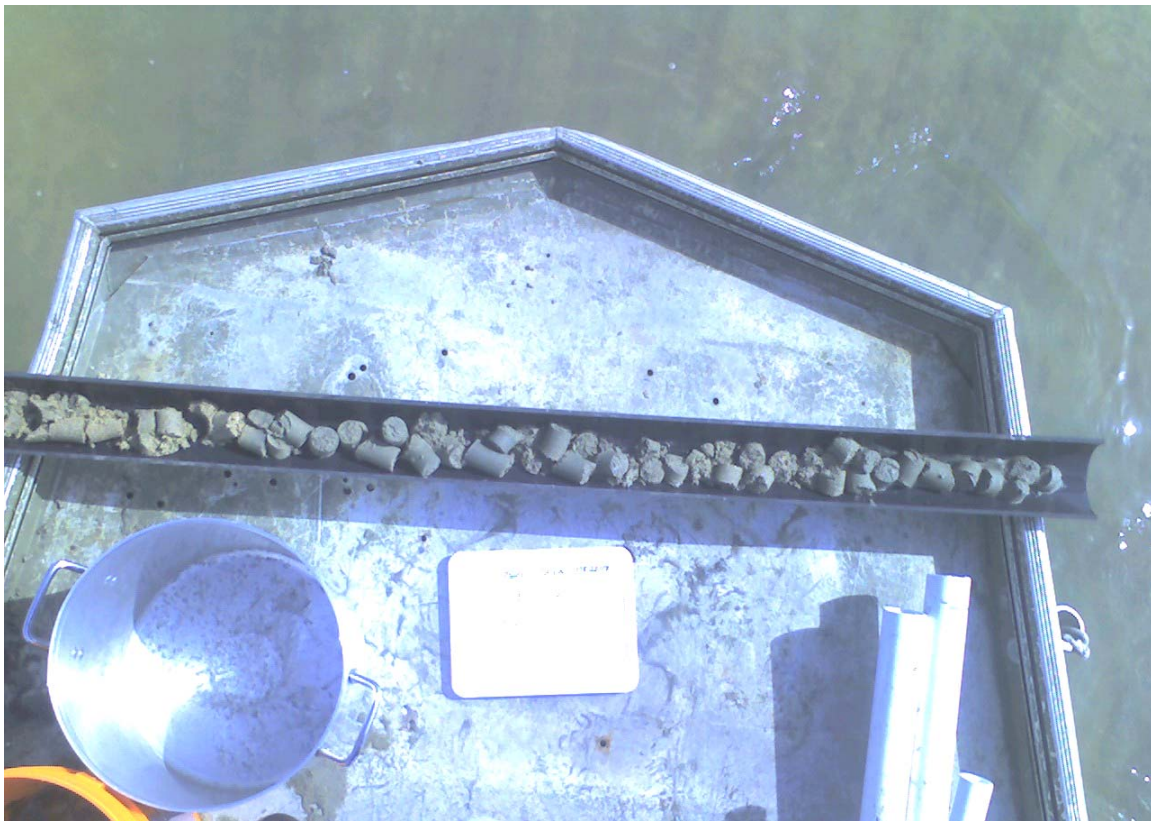
As indicated in field logs, the cores consisted of continuous profiles of brown (dry) and gray (wet) sand. Material was not cohesive and readily eroded with water although the drier cores readily segmented while retaining their initial cylindrical shape. No distinct strata were noted in any sampled cores with the entire length of each core consisting of fine sands with no observable clays/silts, or organic layers. Photographs of all cores are found in Appendix B.

Photograph of typical core segment from Bolsa Chica flood shoal dredge area.

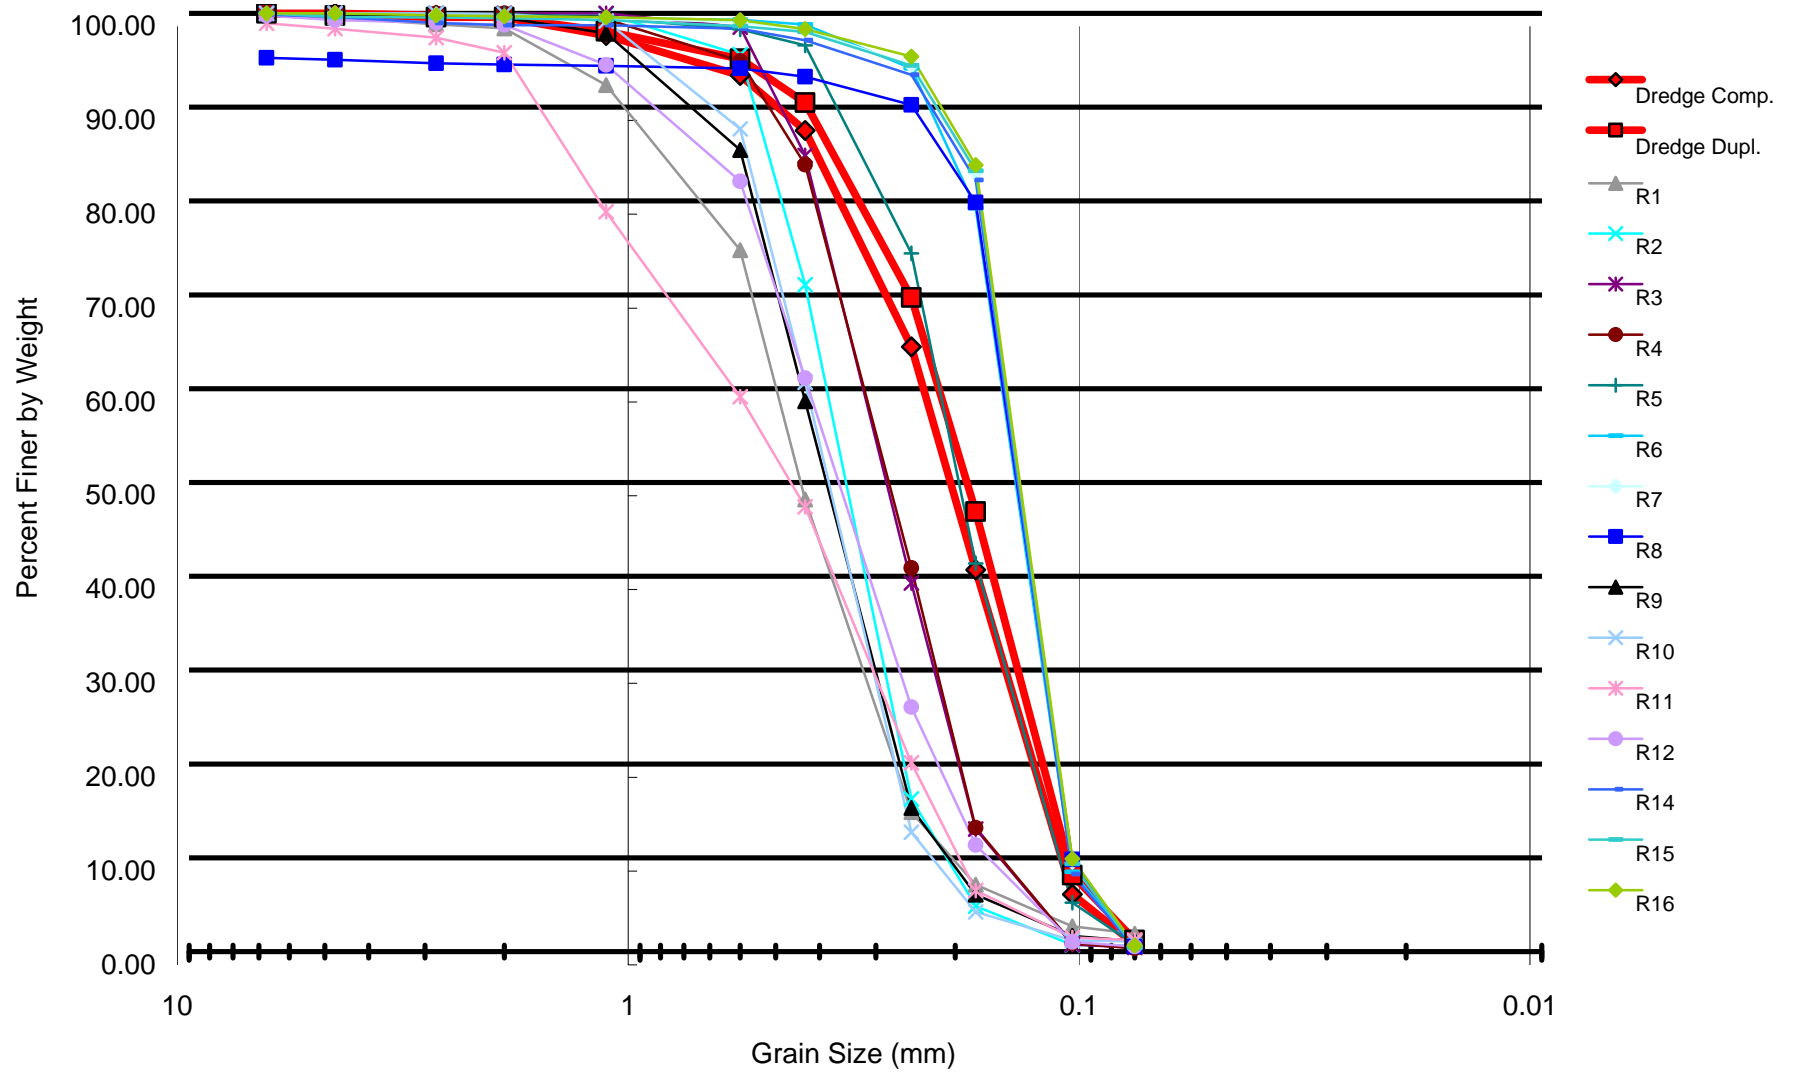
Figure
3

Grain size analyses will be performed on the test composite and receiver site samples following the EPA/USACE-approved sieve and hydrometer method (ASTM 1967). Percent sand, silt, and clay have been reported to 0.01 percent, along with the corresponding diameter in millimeters and cumulative grain size distribution curves (Figure 3).

Grain size samples for the receiver site were sieved and a gradation curve established for each sample (Figure 3). A composite grain size gradation “envelope” was prepared from all receiver site sample locations using plots of the coarsest and finest grain sizes along the transects and compared to grain size results from the proposed dredged material

Grain Size Data
Percent Finer by Weight
May 2008

Sediments to be dredged from the Bolsa Chica Wetlands FTB inlet flood shoal were evaluated for compatibility with the down drift receiver beach that is the required recipient of maintenance dredge bypass sands. The material was found to be nearly pure sand at a 99% sand fraction, and the material was well within the central portion of the grain size envelope described by the grain size curves of the receiver beach (Figure 3). Based on these results, the material is highly compatible with the receiver beach.
